Protecting the Eiffel Tower from the Onset of Corrosion

The World-Renowned Structure Is Painted for the 19th Time

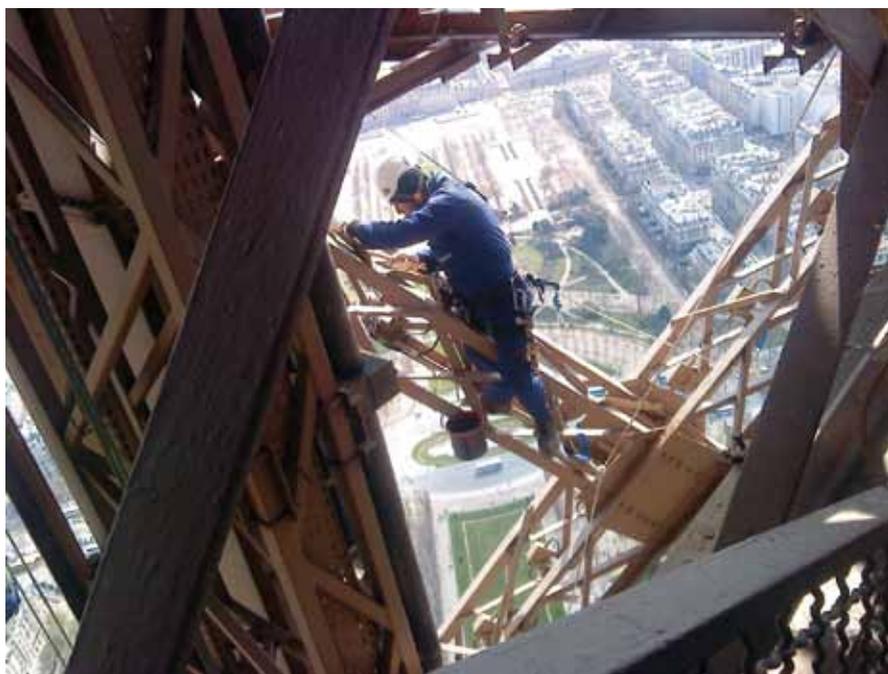
The 19th repainting of the Eiffel Tower is being done manually by 25 painters who climb on girder beams at altitudes of up to 300 m. Photo courtesy of Jotun.

harnesses attached to the girder beams as they climb along the structure to coat all metal surfaces. Security cords allow freedom of movement while keeping the workers secured to the tower. Tools, including paint brushes, are worn on a waist or wrist belt. Buckets of paint are hooked onto the tower's metal braces. Protection netting, coated with a polymer film that renders it drip-free, is installed around the work area to catch falling objects or paint chips. For the current repainting job, 50 km of security cord and 5 acres (20,235 m²) of protection netting will be used.

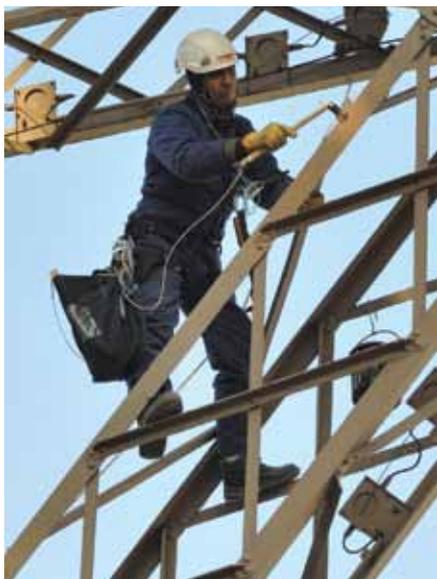
The same methods employed over 100 years ago are used today to sand, clean, spot treat for corrosion, and apply a coat of modern day, urethane alkyd-based paint. Painters wear security harnesses attached to the girder beams as they climb along the structure to coat all metal surfaces. Photo by C. Bamale, courtesy of SETE.

provides an opportunity to inspect the structure and replace corroded metallic parts if needed. At the start of this painting campaign, an initial assessment of the tower's entire surface identified the most corroded zones, which comprised about 5% of the total surface. These areas were treated with two coats of an anti-corrosion primer, and the rest of the structure was industrially steam cleaned before the topcoat was applied.

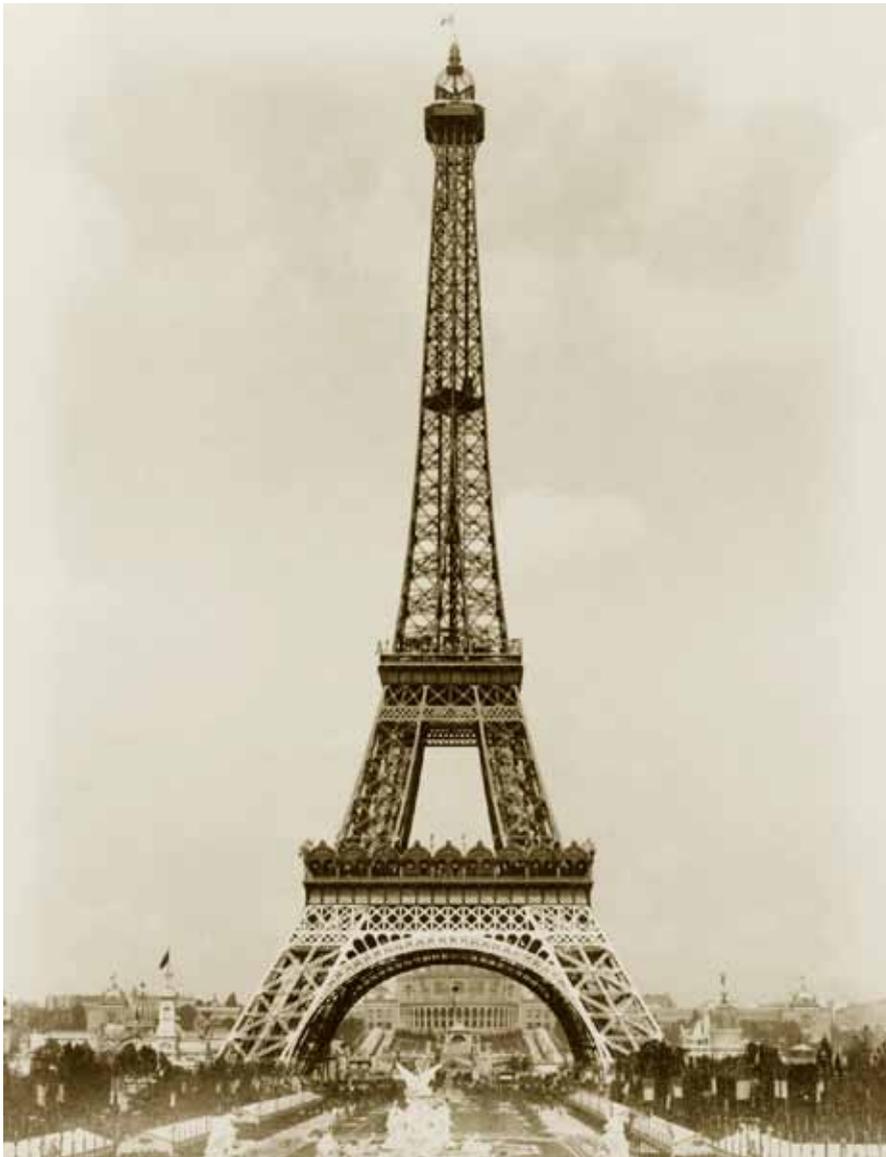
Shown is the newly constructed Eiffel Tower as it appeared during the Paris Universal Exhibition of 1889. Photo available from the U.S. Library of Congress Prints and Photographs Division.

The very first coat of paint, a reddish-brown color named “Venice Red,” was applied in the workshop before the tower was assembled. The second and third coats applied were linseed oil, and a reddish-brown glazed fourth coat was applied in May 1889 around the time the tower was first opened to the public. The fourth coat alone cost 60,000 French gold francs and was guaranteed for one year. Several years later, in 1892, the tower’s previous coating was washed and a new coat of paint was applied. This coat cost 57,000 French gold francs and was guaranteed, with maintenance, for five years.
